**Flood Control Project Maintenance
Levee Inspections
LMA District Cover Sheet
Spring 2010 Levee Inspection Results**

San Joaquin County Flood Control and Water Conservation District

Spring 2010 Levee Inspection Results

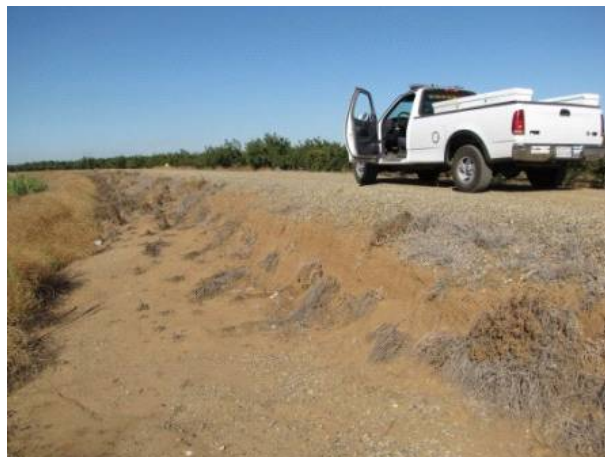
Levee Mile Report Line	3
Start Levee Mile	1.52
End Levee Mile	1.52
Location	Water Side
Category	Earthen Levee
Item	Erosion / Bank Caving

View of erosion of waterward levee slope looking upstream.

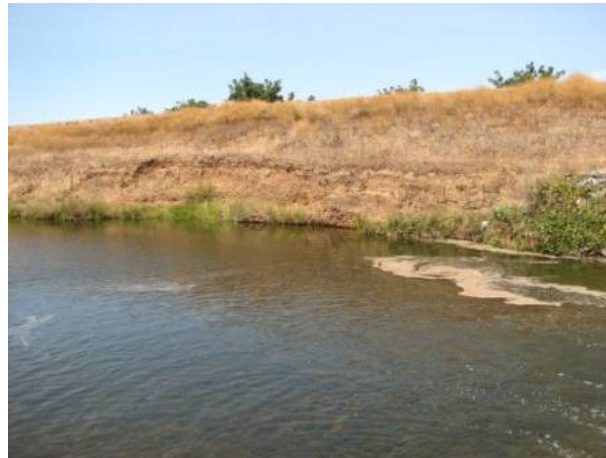
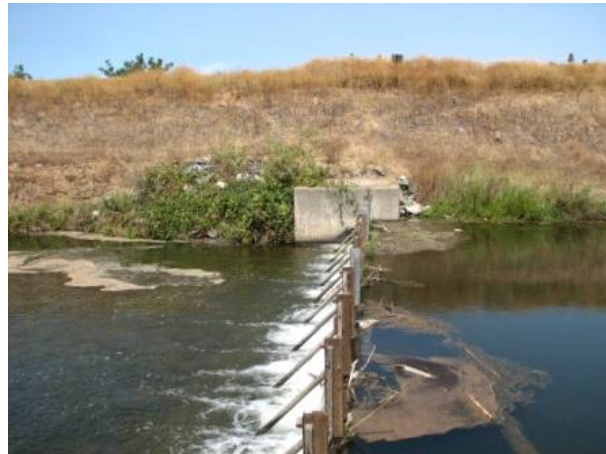
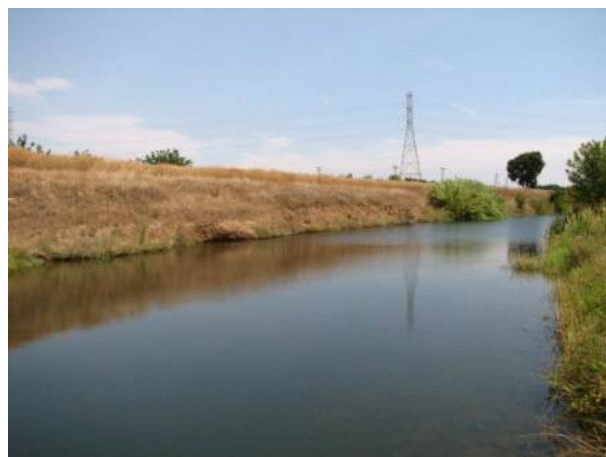
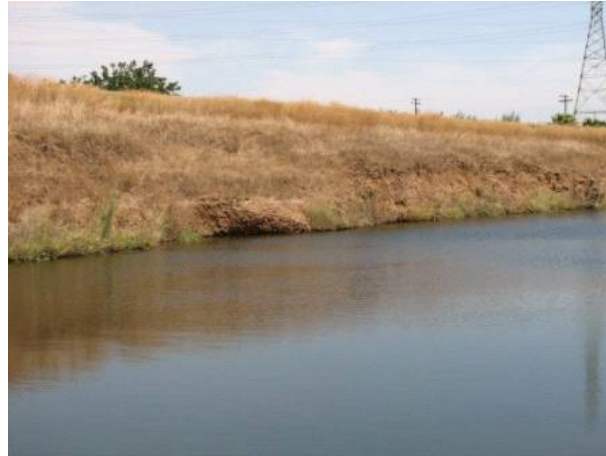
Levee Mile Report Line	4
Start Levee Mile	1.55
End Levee Mile	1.62
Location	Water Side
Category	Supplemental
Item	DWR Erosion Survey

4	1.55	1.62	Supplemental	DWR Erosion Survey	WS	U	Inspector Comments: 2009: No change observed; erosion is upstream and downstream of drop structure; bank erosion associated with high velocities; recommend annual assessment and monitoring of critical erosion site, per CLRO CES Evaluation 2008 Report; previously rated "U" [2009 SiteID:NA0017U15RM1.58]	38.040170 ° -121.033800 °	38.040170 ° -121.033800 °	14 Y
5	1.93	1.93	Earthen Levee	Vegetation	LS	C	Remove the wild growth other than native grasses from the levee slopes.	38.038103 ° -121.039509 °	38.038103 ° -121.039509 °	996 Y
6	1.96	1.98	Earthen Levee	Vegetation	LS	C	Remove the wild growth other than native grasses from the levee slopes.	38.037832 ° -121.039834 °	38.037577 ° -121.040065 °	997 Y
7	2.02	2.02	Earthen Levee	Vegetation	LS	C	Remove the wild growth other than native grasses from the levee slopes.	38.037116 ° -121.040443 °	38.037116 ° -121.040443 °	998 Y

2009: No change observed; erosion is upstream and downstream of drop structure; bank erosion associated with high velocities; recommend annual assessment and monitoring of critical erosion site, per CLRO CES Evaluation 2008 Report; previously rated "U" [2009 SiteID:NA0017U15RM1.58]

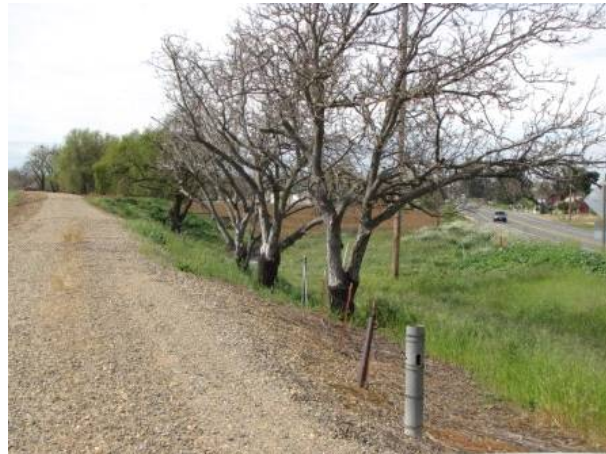
Levee Mile Report Line	8
Start Levee Mile	2.34
End Levee Mile	2.57
Location	Land Side
Category	Earthen Levee
Item	Vegetation

View of vegetation on the landward slope looking upstream.

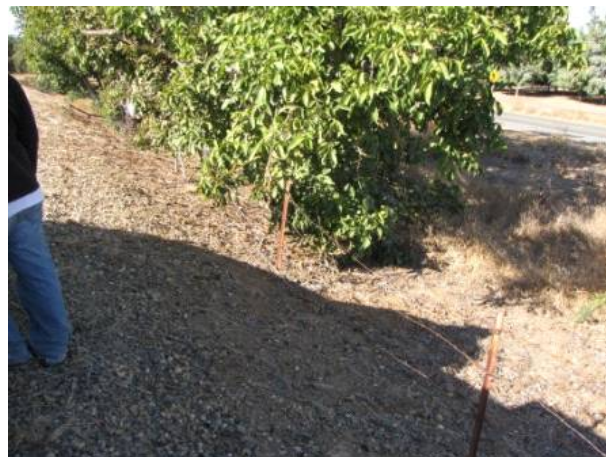
Levee Mile Report Line	9
Start Levee Mile	2.36
End Levee Mile	2.36
Location	Land Side
Category	Earthen Levee
Item	Trim / Thin Trees

View of trees on landward slope looking upstream.

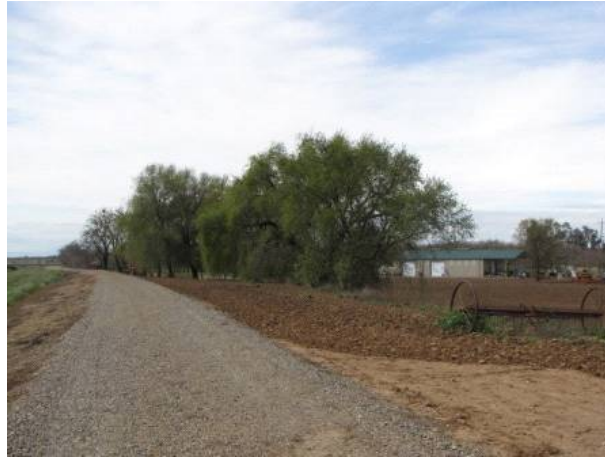
dpesaven_s_20100518_573.jpg

View of the landward shoulder where a landowner has disced the levee looking downstream.

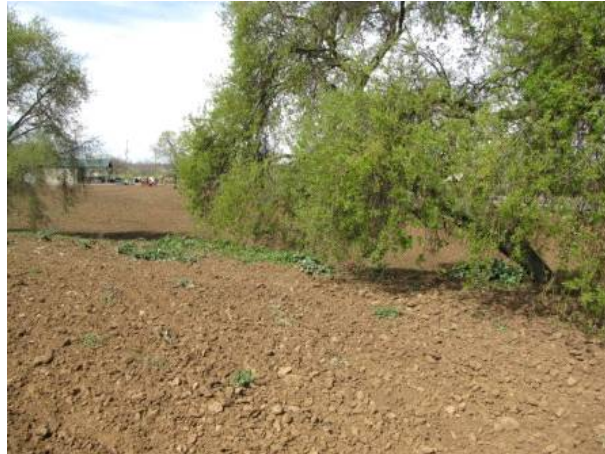
Levee Mile Report Line	12
Start Levee Mile	2.48
End Levee Mile	2.48
Location	Land Side
Category	Earthen Levee
Item	Trim / Thin Trees

View of a tree blocking visibility on the landward slope looking downstream.

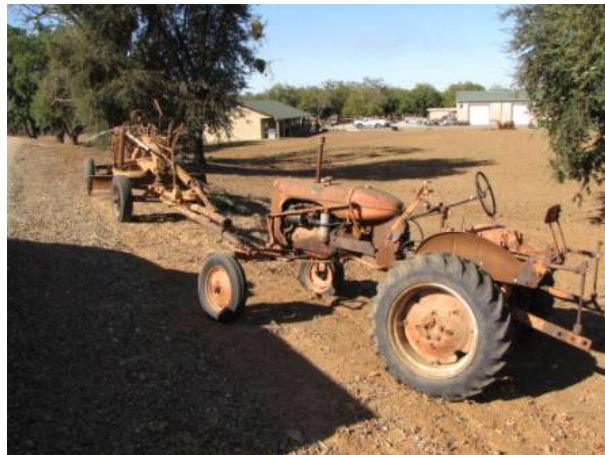
Levee Mile Report Line	13
Start Levee Mile	2.54
End Levee Mile	2.54
Location	Land Side
Category	Earthen Levee
Item	Encroachments

View of equipment on the landward slope of the levee looking upstream.

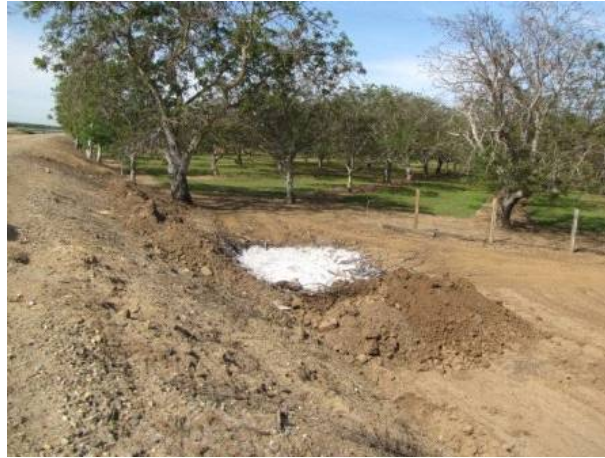
dpesaven_s_20100316_271.jpg

Landowner has dug into the toe of the levee for the burn pile. Remove the debris and recompact the excavation at LM 2.61 on the landward side of the levee.

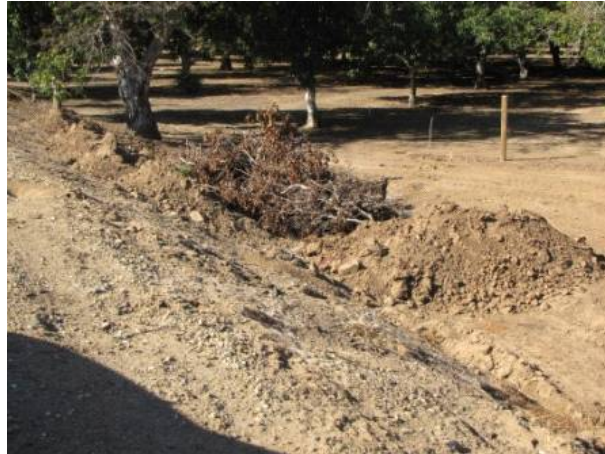
Levee Mile Report Line	14
Start Levee Mile	2.61
End Levee Mile	2.61
Location	Land Side
Category	Earthen Levee
Item	Slope Stability

LMR No	Levee Mile		Category	Item	Location	Rating	Action/Comment	GPS Latitude/Longitude		Issue No.
	Start	End						Start	End	
14	2.61	2.61	Earthen Levee	Slope Stability	LS	M	Repair slope instability. Inspector Comments: Pile is still active and there are new excavations. New material has been placed in the excavation.	38.030981 ° -121.047521 °	38.030981 ° -121.047521 °	958 Y
15	2.68	2.68	Earthen Levee	Encroachments	LS	C	Prunings Inspector Comments: Burn pile has been burned but some new material remains.	38.030223 ° -121.048407 °	38.030223 ° -121.048407 °	2
16	2.68	2.71	Earthen Levee	Encroachments	LS	PO	Buildings Inspector Comments: retaining wall at toe of slope & irrigation recently placed	38.030173 ° -121.048432 °	38.029949 ° -121.048732 °	66 Y
17	2.73	2.73	Earthen Levee	Encroachments	LS	PO	Landscaping	38.030185 ° -121.049397 °	38.030185 ° -121.049397 °	3
18	2.74	2.75	Earthen Levee	Encroachments	LS	PO	Buildings Inspector Comments: Retaining wall at landside toe of levee	38.029641 ° -121.049165 °	38.029505 ° -121.049372 °	959 Y

View of farmer's excavation in the levee toe for a burn pile location looking upstream.

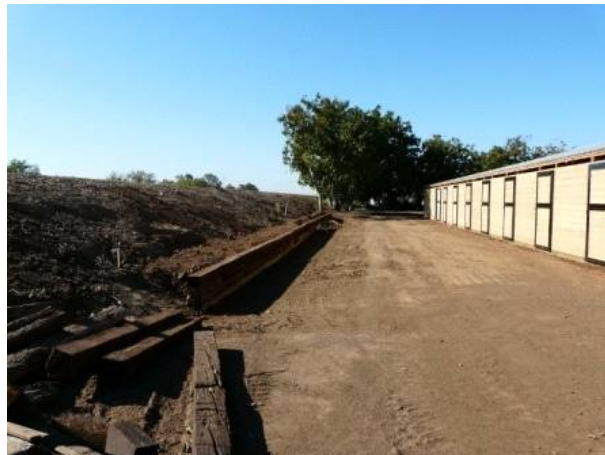
Levee Mile Report Line	16
Start Levee Mile	2.68
End Levee Mile	2.71
Location	Land Side
Category	Earthen Levee
Item	Encroachments

Recently built retaining wall at toe of landside levee at LM 2.68.

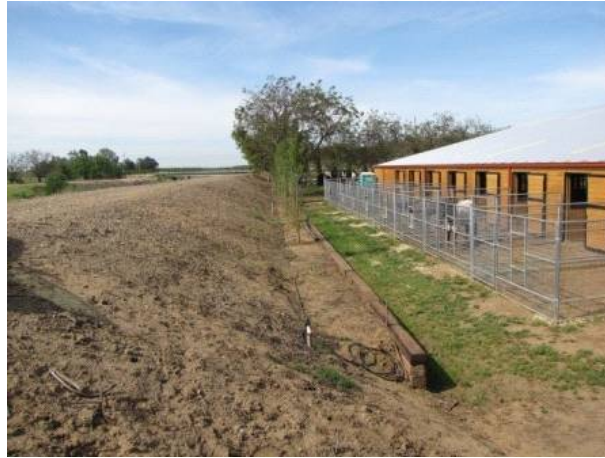
dpesaven_s_20100316_265.jpg

Updated view as of Spring 2009. Landscaping and irrigation has been added at the toe of the levee.

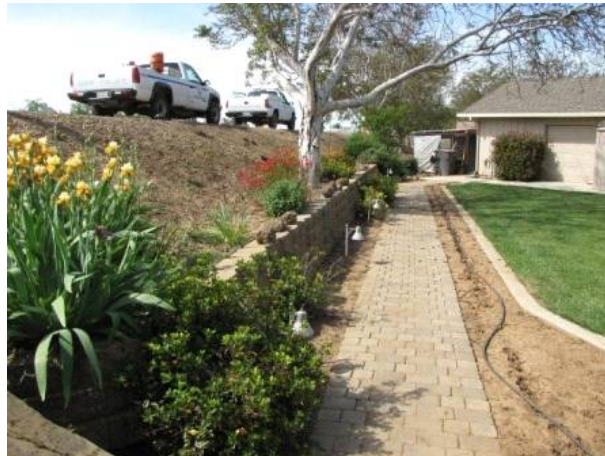
Levee Mile Report Line	18
Start Levee Mile	2.74
End Levee Mile	2.75
Location	Land Side
Category	Earthen Levee
Item	Encroachments

View of retaining wall and landscaping along the landward toe of the levee.

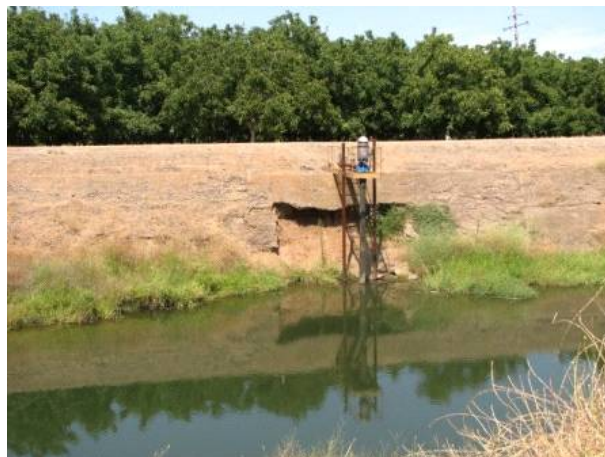
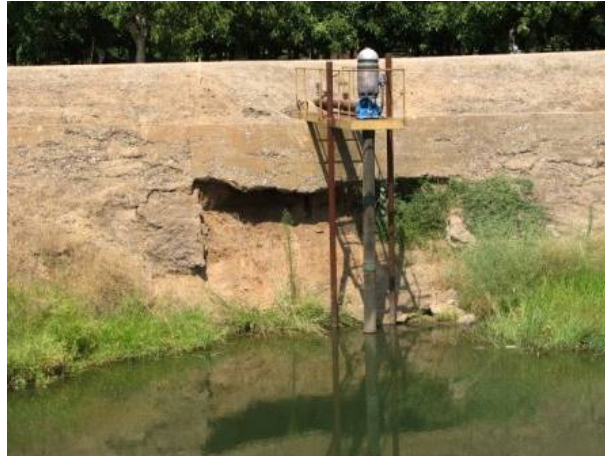
Levee Mile Report Line	24
Start Levee Mile	3.14
End Levee Mile	3.15
Location	Water Side
Category	Supplemental
Item	DWR Erosion Survey

24	3.14	3.15	Supplemental	DWR Erosion Survey	WS	M	Inspector Comments: 2009: downward creep of the soil, possibly caused during pipe installation; erosion is 2-3 ft cut into the bank; vertical pump inlet is located adjacent to erosion; District personnel were made aware of this during the site survey [2009 SiteID:NA0017U15RM3.14]	38.026257 ° -121.054829 °	38.026257 ° -121.054829 °	15 Y
25	3.19	3.19	Earthen Levee	Encroachments	LS	M	Prunings Inspector Comments: Burn pile has been burned but new material has been placed.	38.025647 ° -121.055484 °	38.025647 ° -121.055484 °	8
26	3.26	3.26	Earthen Levee	Encroachments	LS	M	Prunings Inspector Comments: Burn pile has been burned but new material has been placed.	38.025053 ° -121.056457 °	38.025053 ° -121.056457 °	9

2009: downward creep of the soil, possibly caused during pipe installation; erosion is 2-3 ft cut into the bank; vertical pump inlet is located adjacent to erosion; District personnel were made aware of this during the site survey [2009 SiteID:NA0017U15RM3.14]

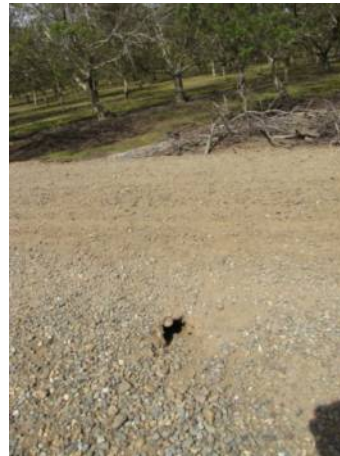
Levee Mile Report Line	29
Start Levee Mile	3.35
End Levee Mile	3.35
Location	Crown
Category	Earthen Levee
Item	Animal Control

View of a rodent hole in the crown of the levee looking landward.

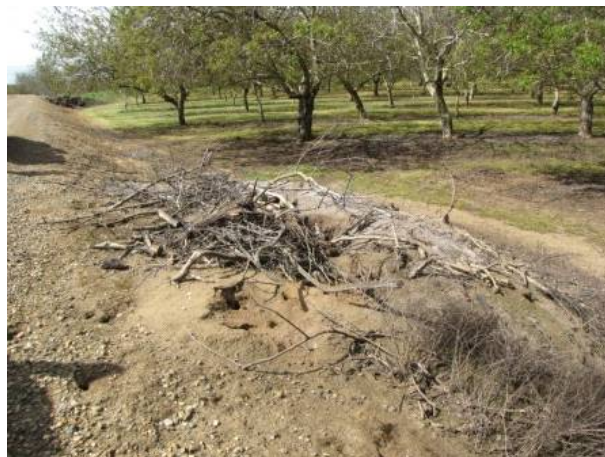
Levee Mile Report Line	30
Start Levee Mile	3.35
End Levee Mile	3.35
Location	Land Side
Category	Earthen Levee
Item	Encroachments

View of prunings on the landward slope looking downstream. Note the evidence of rodents.

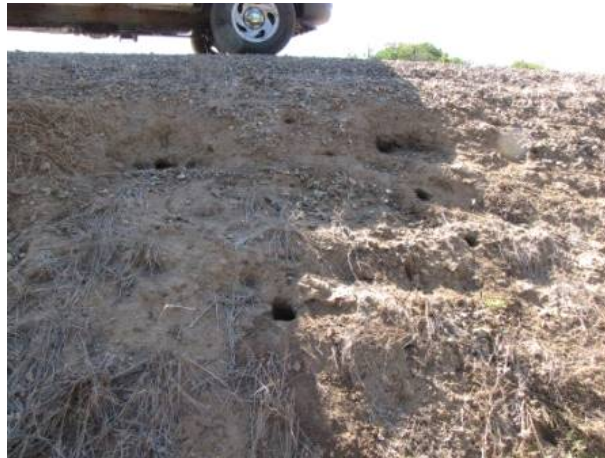
dpesaven_s_20100316_285.jpg

View of rodent holes on landward slope of levee.

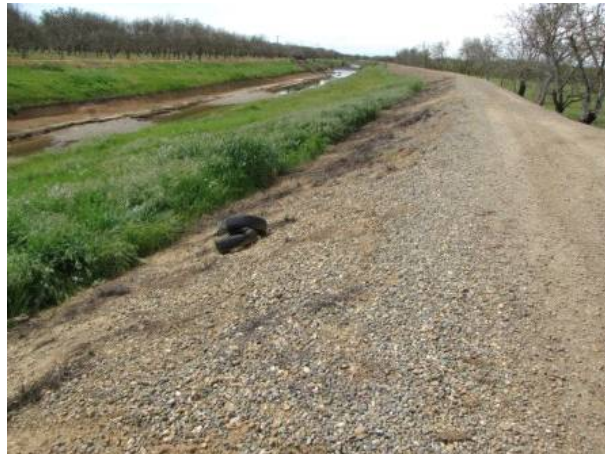
Levee Mile Report Line	33
Start Levee Mile	3.42
End Levee Mile	3.42
Location	Water Side
Category	Earthen Levee
Item	Encroachments

View of tires on the waterward slope looking downstream.

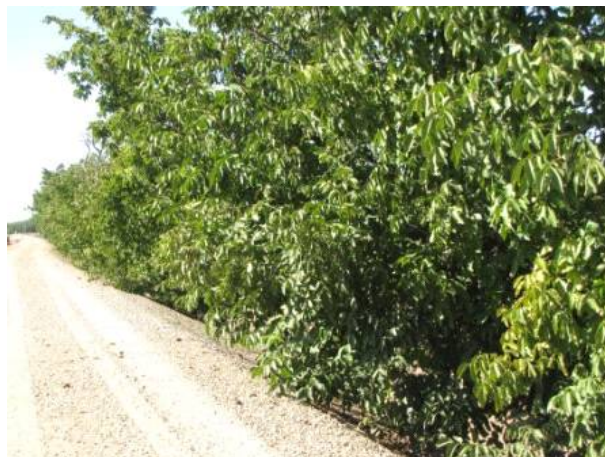
Levee Mile Report Line	34
Start Levee Mile	3.50
End Levee Mile	3.55
Location	Land Side
Category	Earthen Levee
Item	Trim / Thin Trees

View of trees obstructing the view and access along landward slope of levee looking downstream.

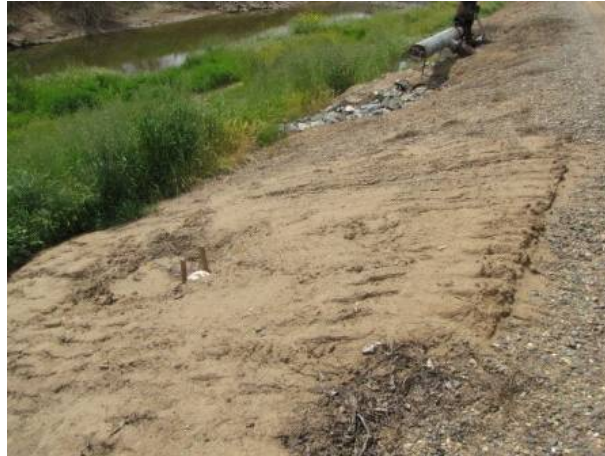
View of a recently place pipe in the waterward slope looking downstream.

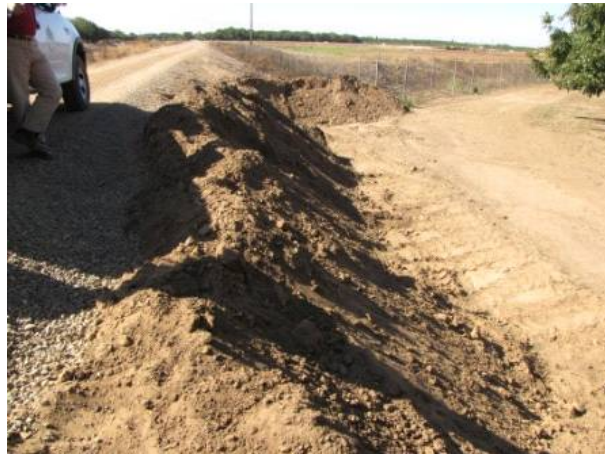
Levee Mile Report Line	39
Start Levee Mile	3.64
End Levee Mile	3.66
Location	Land Side
Category	Earthen Levee
Item	Slope Stability

View of excavations and embankments created by landowner along the landward slope looking downstream.

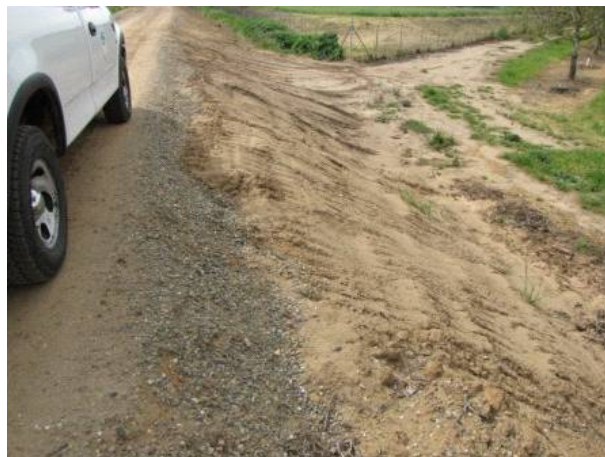
Levee Mile Report Line	39
Start Levee Mile	3.64
End Levee Mile	3.66
Location	Land Side
Category	Earthen Levee
Item	Slope Stability

Updated view of the location with a partially completed repair looking downstream.

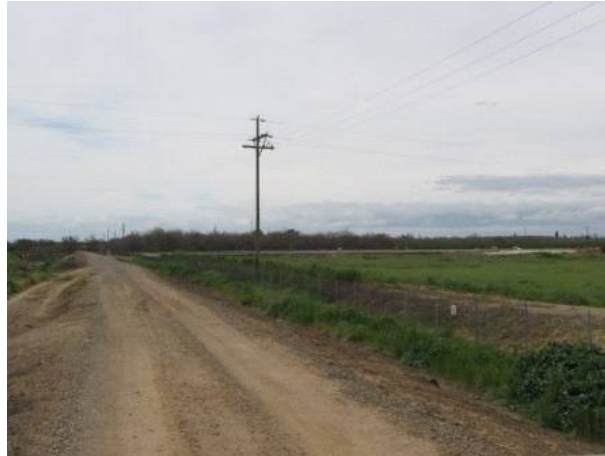
View of vegetation on the landward toe looking downstream.

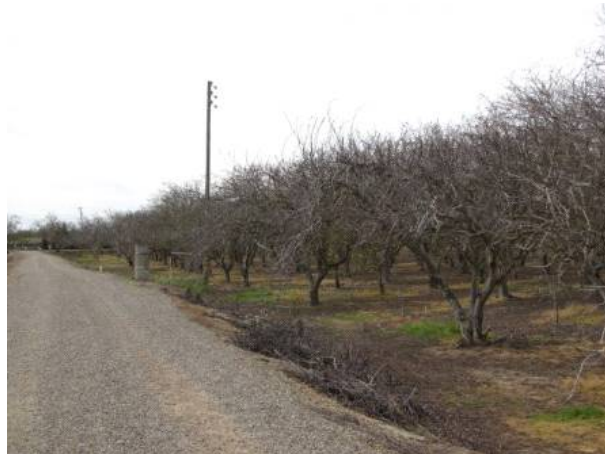
Levee Mile Report Line	41
Start Levee Mile	3.94
End Levee Mile	3.98
Location	Land Side
Category	Earthen Levee
Item	Encroachments

View of pruning on the landward slope looking downstream.

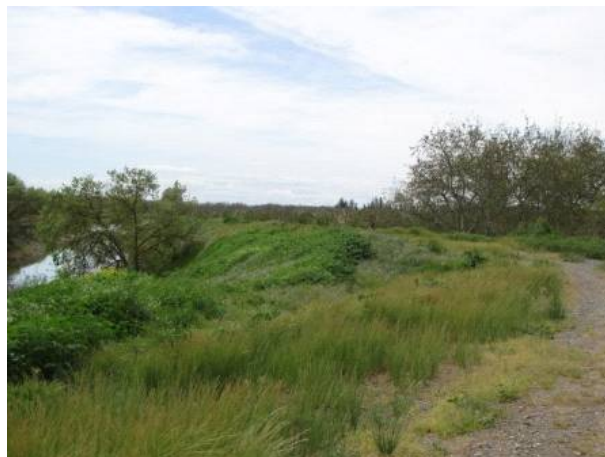
Levee Mile Report Line	46
Start Levee Mile	4.29
End Levee Mile	4.74
Location	Water Side
Category	Earthen Levee
Item	Vegetation

View of vegetation on the waterward slope looking downstream.

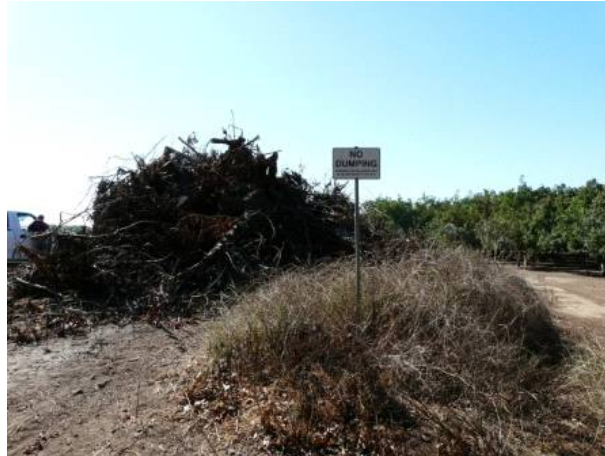
Example of a prunings pile immediately adjacent to access road at LM 4.29. Evidence of habitual burnings at this site.

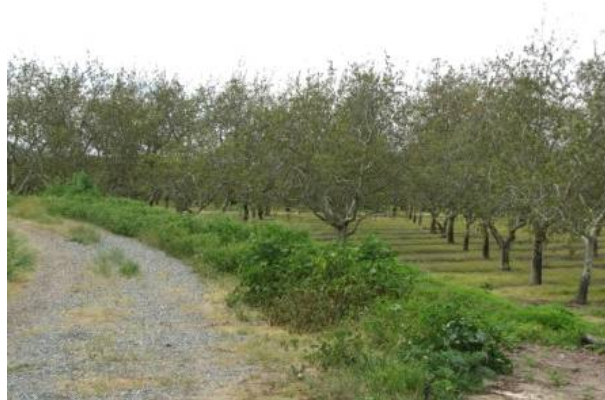
Levee Mile Report Line	48
Start Levee Mile	4.30
End Levee Mile	4.98
Location	Land Side
Category	Earthen Levee
Item	Vegetation

View of vegetation on the landward slope looking downstream.

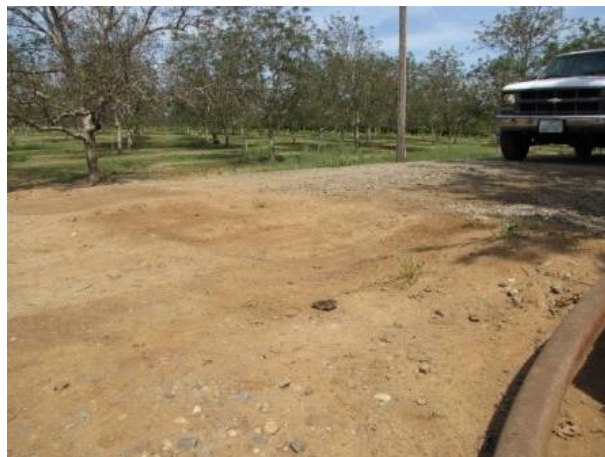
Levee Mile Report Line	51
Start Levee Mile	4.73
End Levee Mile	4.73
Location	Land Side
Category	Earthen Levee
Item	Crown Surface / Depressions / Rutting

Depression in roadway due to maintenance performed on a pipe penetration. The depression is a sign that the backfill material may not have been compacted properly. Recompact levee material and re-grade the levee crown.

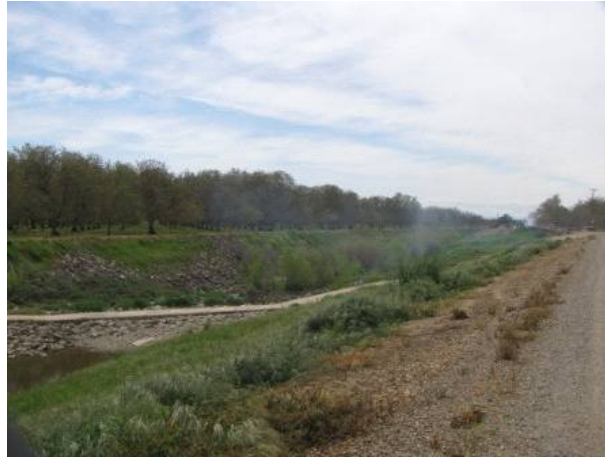
View of vegetation on the waterward slope looking downstream.

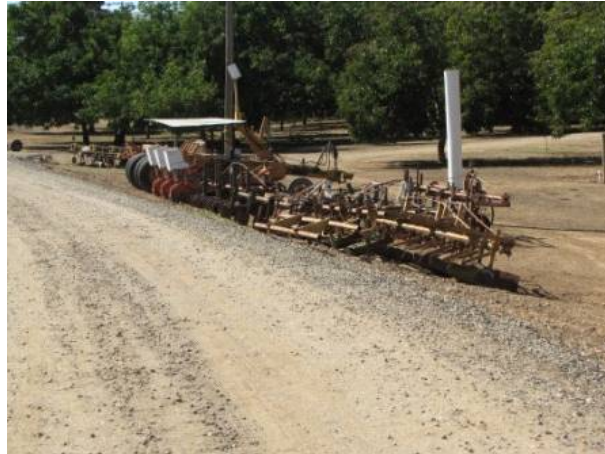
Levee Mile Report Line	53
Start Levee Mile	4.96
End Levee Mile	4.96
Location	Land Side
Category	Earthen Levee
Item	Encroachments

View of equipment along the landward slope looking downstream.

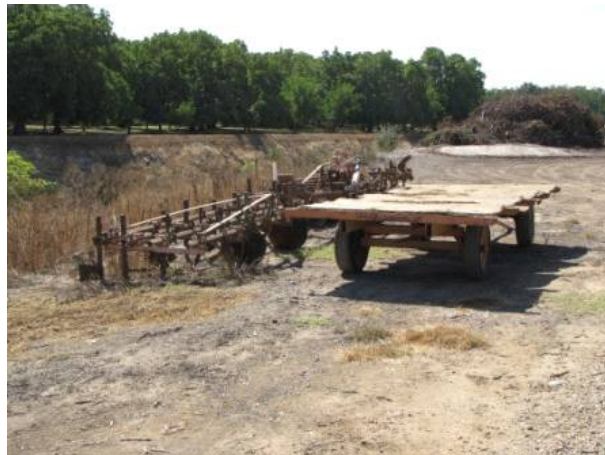
Levee Mile Report Line	54
Start Levee Mile	4.96
End Levee Mile	4.96
Location	Water Side
Category	Earthen Levee
Item	Encroachments

View of equipment along the waterward side of the levee crown looking downstream.

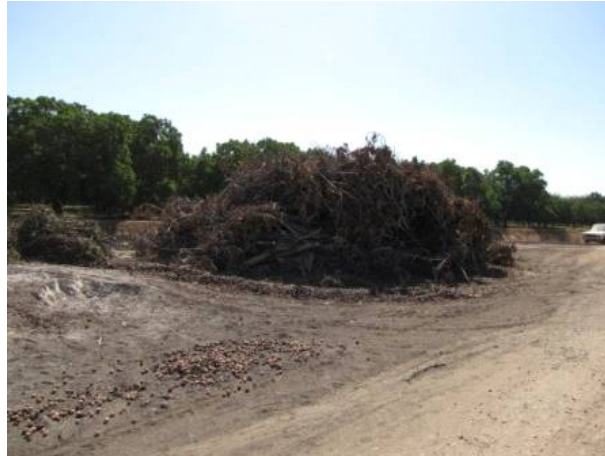
View of prunings pile along the waterward side of the crown looking downstream.

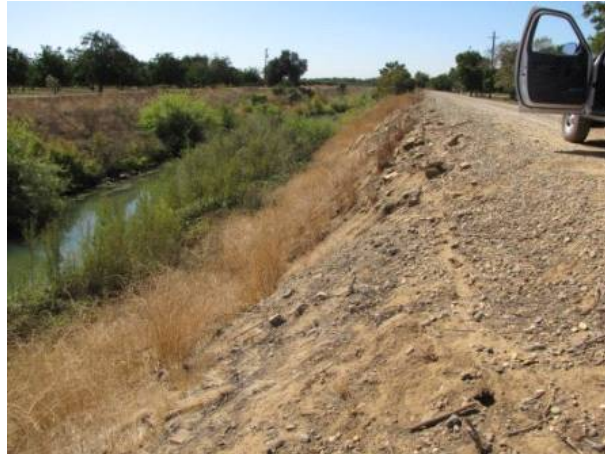
Levee Mile Report Line	58
Start Levee Mile	5.14
End Levee Mile	5.14
Location	Water Side
Category	Earthen Levee
Item	Slope Stability

View of a slip in the waterward levee slope looking downstream.

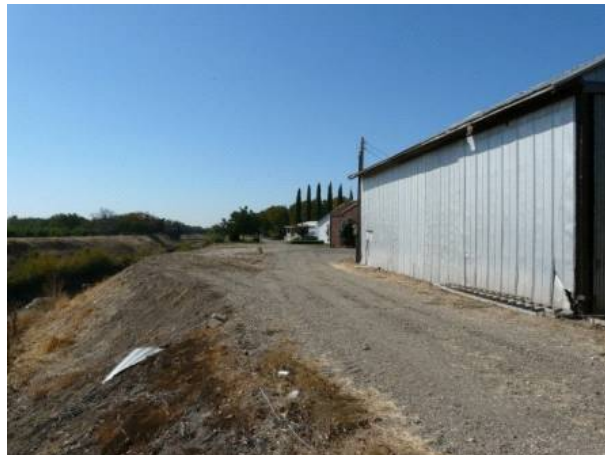
Levee Mile Report Line	62
Start Levee Mile	5.38
End Levee Mile	5.45
Location	Land Side
Category	Earthen Levee
Item	Encroachments

Building located immediately adjacent to access road approximately from LM 5.38 to 5.45

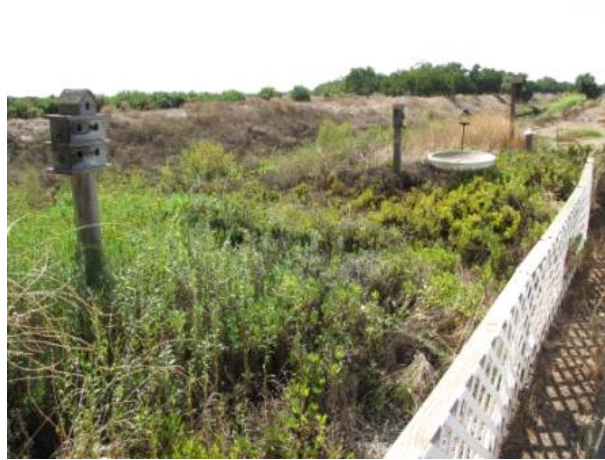
View of landscaping planted along the waterward side of the access road impacting visibility and the ability to floodfight looking downstream.

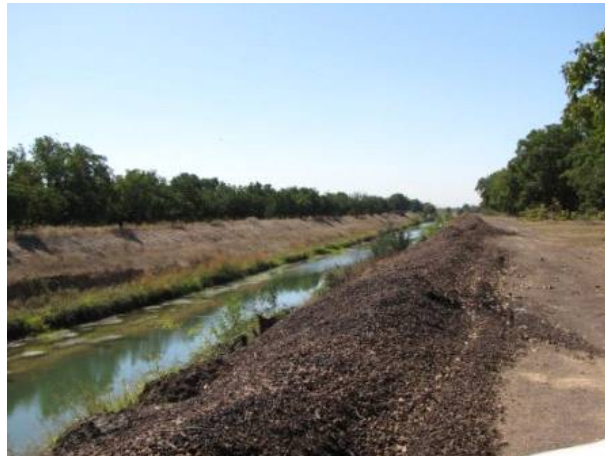
Levee Mile Report Line	65
Start Levee Mile	5.60
End Levee Mile	5.65
Location	Water Side
Category	Earthen Levee
Item	Encroachments

View of discarded nut shells placed along the waterward slope to be burned looking downstream.

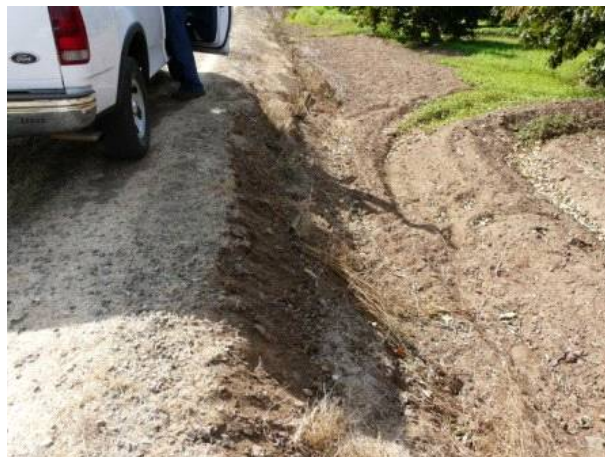
Levee Mile Report Line	75
Start Levee Mile	6.75
End Levee Mile	6.88
Location	Land Side
Category	Earthen Levee
Item	Erosion / Bank Caving

Farming equipment grading into the landside toe of the levee located at LM 6.90. Backfill and compact to design shape and attempt to prevent future damage.

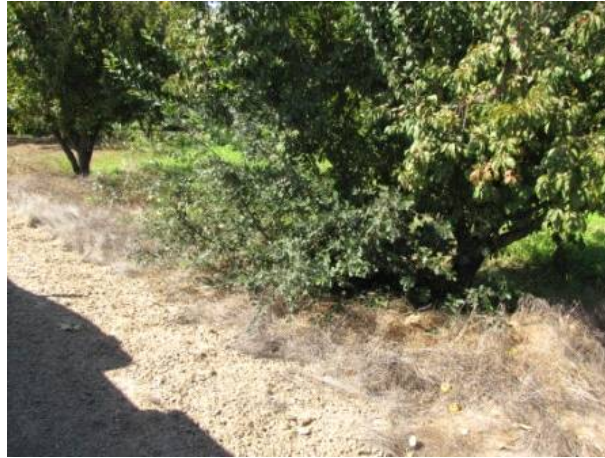
View of trees obstructing visibility and the ability to floodfight along the landward slope.

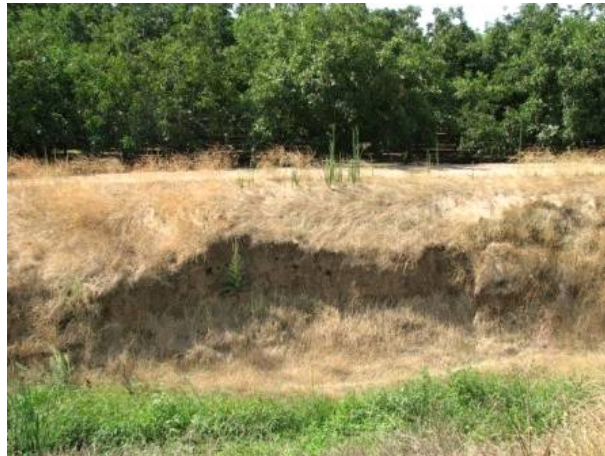
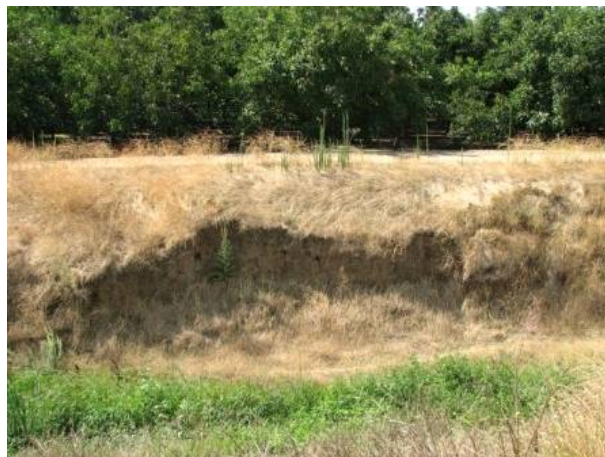
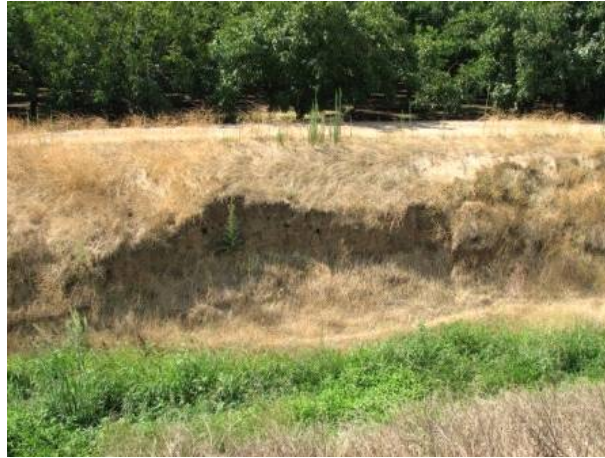
Levee Mile Report Line	78
Start Levee Mile	7.23
End Levee Mile	7.23
Location	Water Side
Category	Supplemental
Item	DWR Erosion Survey

2009: near-vertical scarp on the bank; levee is on high ground [2009 SiteID:NA0017U15RM7.23]

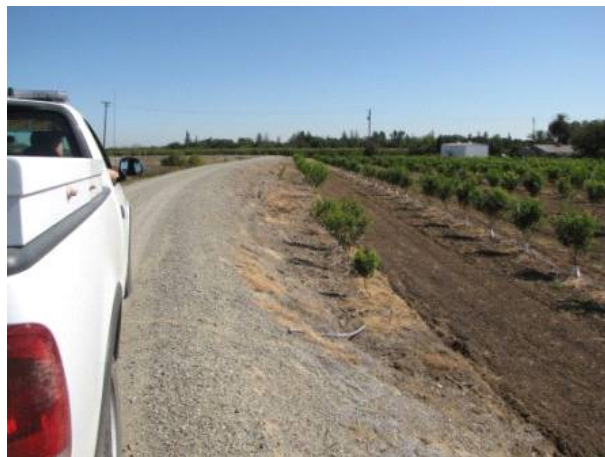
Levee Mile Report Line	90
Start Levee Mile	8.52
End Levee Mile	18.60
Location	Land Side
Category	Earthen Levee
Item	Encroachments

View of recently planted trees along the landward toe looking downstream.

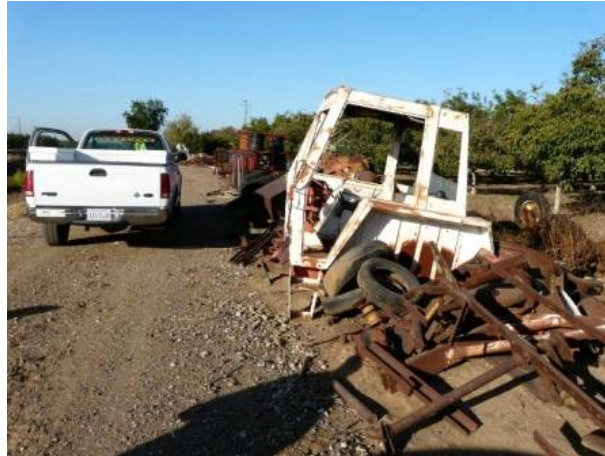
Levee Mile Report Line	92
Start Levee Mile	8.68
End Levee Mile	8.70
Location	Land Side
Category	Earthen Levee
Item	Encroachments
Remove equipment from landside slope of levee at from LM 8.68 to LM 8.70.	
dpesaven_s_20100316_255.JPG

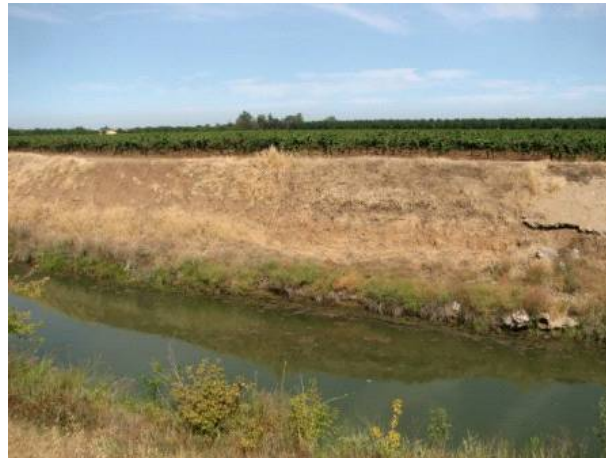
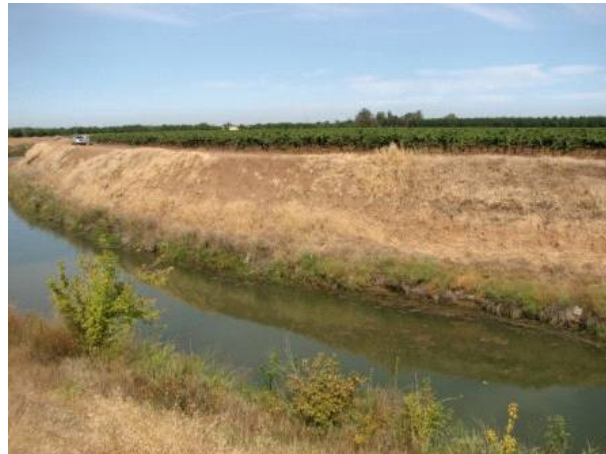
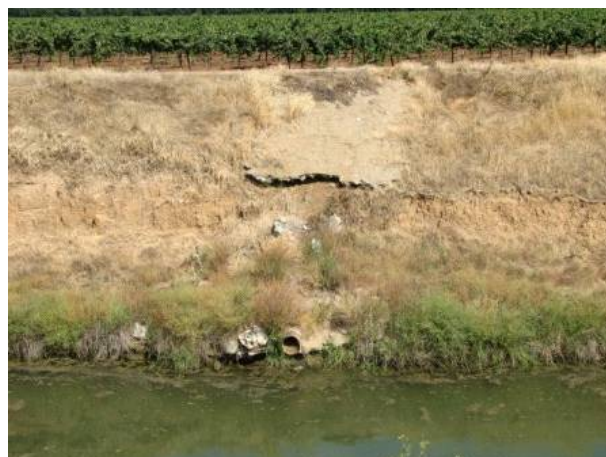
Levee Mile Report Line	98
Start Levee Mile	9.10
End Levee Mile	9.12
Location	Water Side
Category	Supplemental
Item	DWR Erosion Survey

2009: Erosion is incising into the levee; a pipe outlet is located at the levee toe; there are traces of concrete lining originally placed over the slope; levee is on high ground; inspect for potential pipe leak [2009 SiteID:NA0017U15RM9.11]

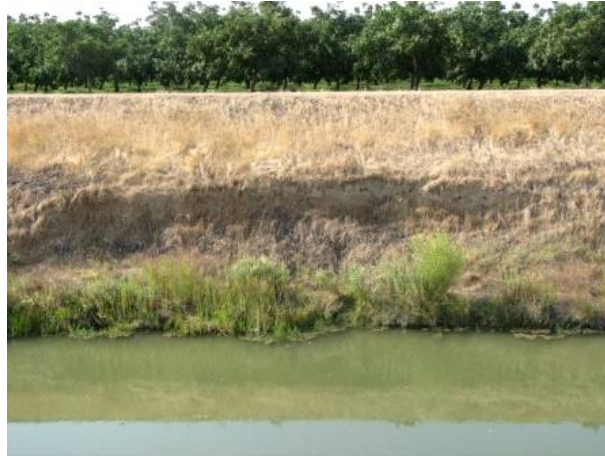
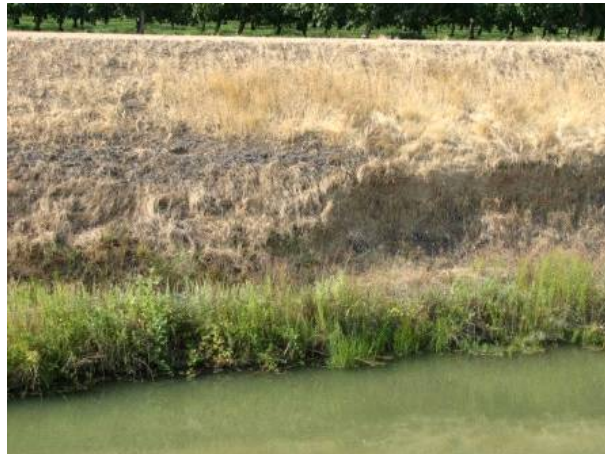
Levee Mile Report Line	99
Start Levee Mile	9.15
End Levee Mile	9.17
Location	Water Side
Category	Supplemental
Item	DWR Erosion Survey
2009: cut of 1-2 ft into the levee along lower 1/2 slope; cut is near-vertical; levee is on high ground [2009 SiteID:NA0017U15RM9.16]	
SJ2009_LM9.16U16 081109C.JPG

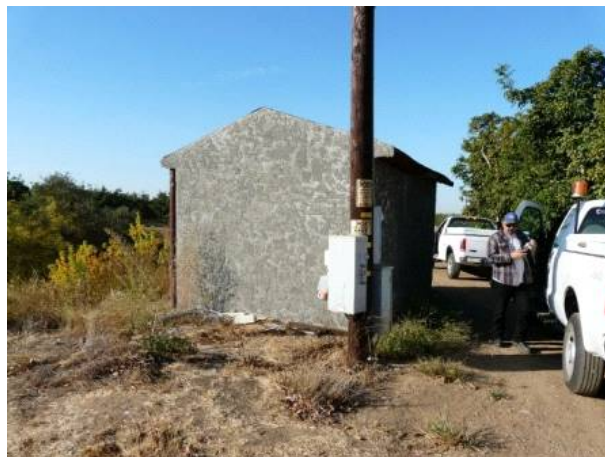
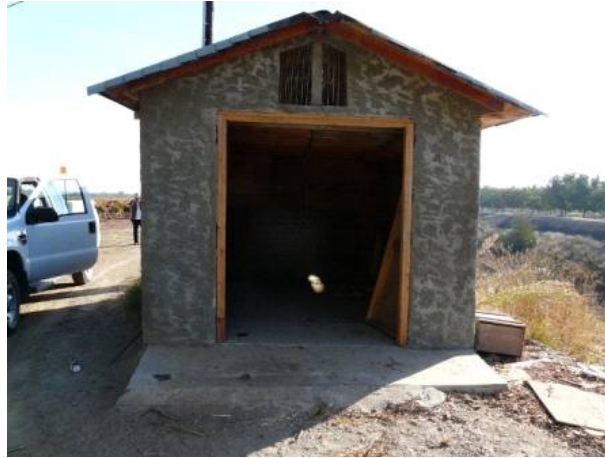
Levee Mile Report Line	102
Start Levee Mile	9.63
End Levee Mile	9.63
Location	Water Side
Category	Earthen Levee
Item	Encroachments
Building located at LM 9.63 on waterside of access road. This building appears to be recently constructed and does not currently contain anything.	
dpesaven_s_20100316_256.JPG

Additional view of building at LM 9.63.

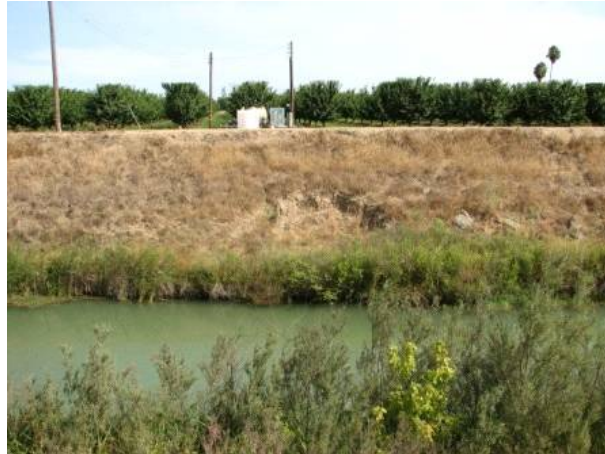
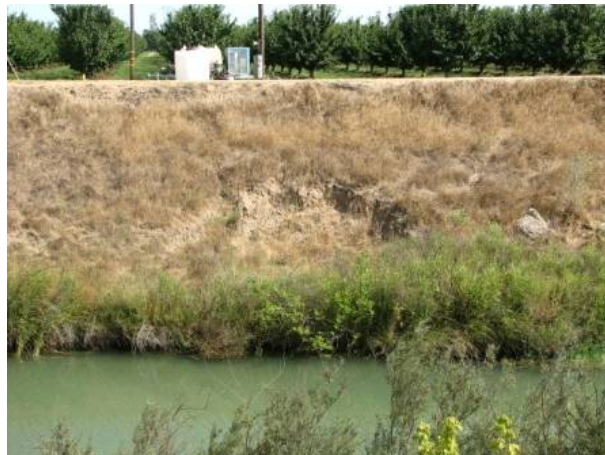
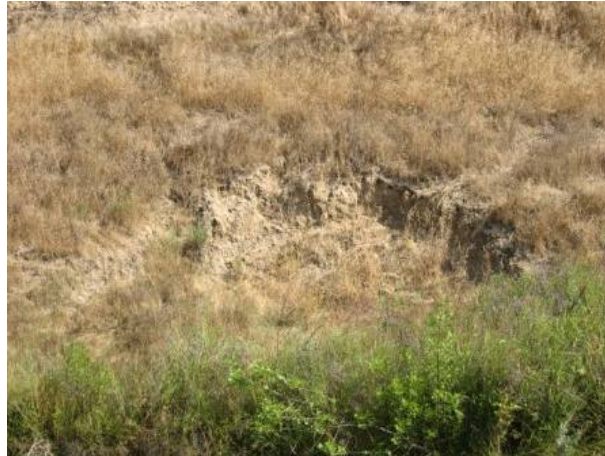
Levee Mile Report Line	108
Start Levee Mile	10.37
End Levee Mile	10.37
Location	Water Side
Category	Supplemental
Item	DWR Erosion Survey

2009: localized erosion; sloughing at the lower slope; small pocket erosion developing [2009 SiteID:NA0017U15RM10.37]

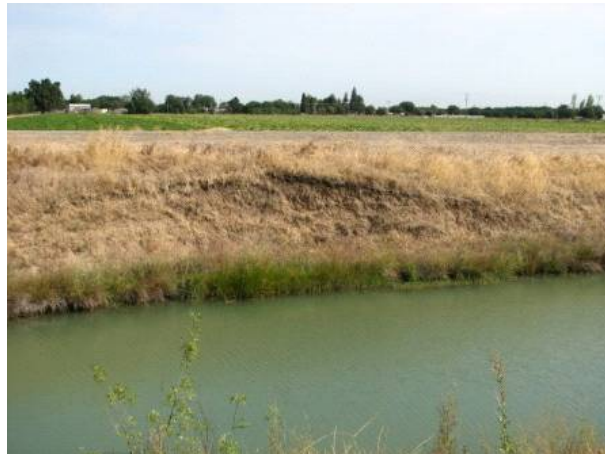
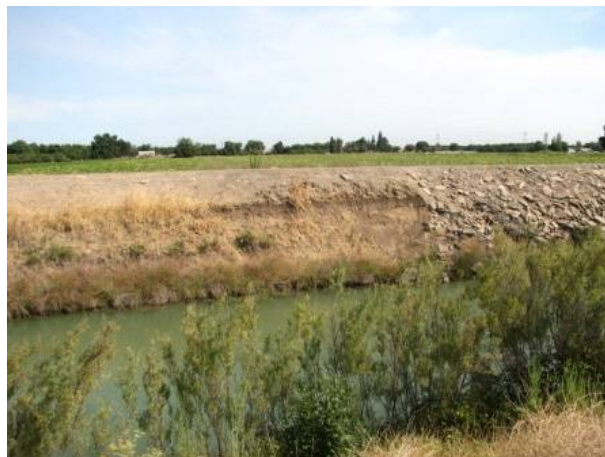
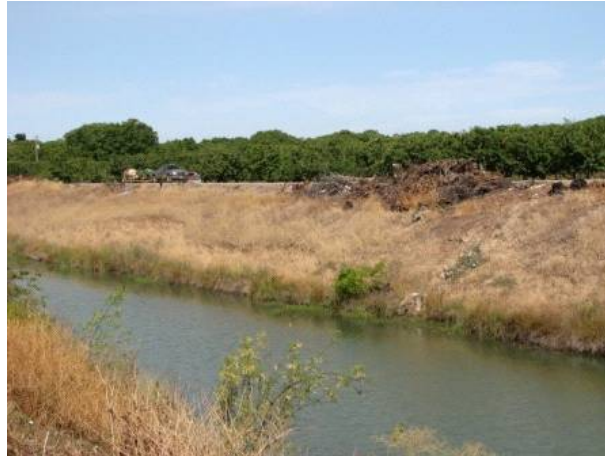
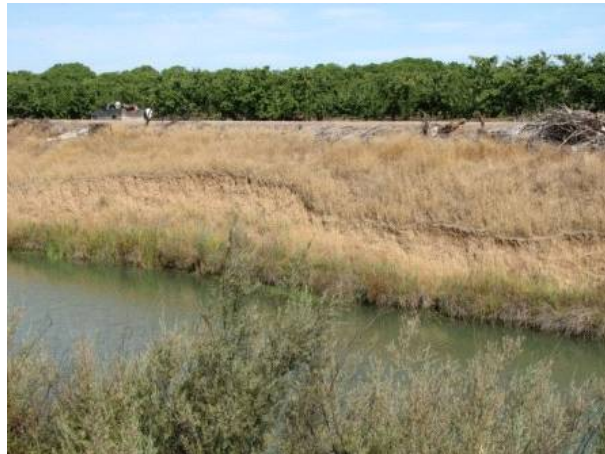
Levee Mile Report Line	111
Start Levee Mile	10.59
End Levee Mile	10.65
Location	Water Side
Category	Supplemental
Item	DWR Erosion Survey

2009: scarp with varying height of 1' - 5'; levee is on high ground; erosion occurs just downstream of rip rap placement; at the time of the survey, there were burn piles at various location along the waterside levee slope [2009 SiteID:NA0017U15RM10.62]

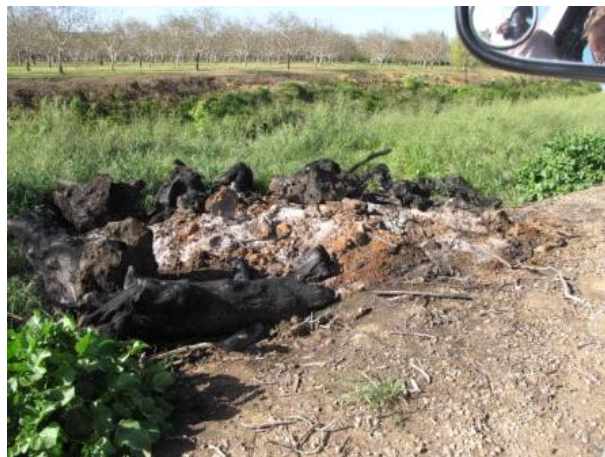
Levee Mile Report Line	112
Start Levee Mile	10.62
End Levee Mile	10.62
Location	Water Side
Category	Earthen Levee
Item	Encroachments

View of the prunings pile on the waterward slope looking downstream.

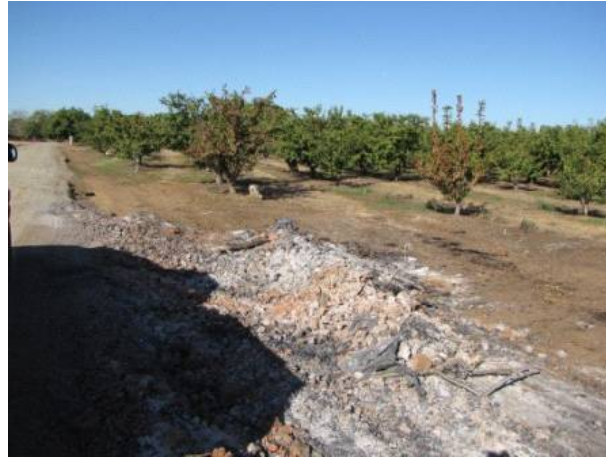
dpesaven_s_20100316_301.jpg

View of debris left from a burn pile on the landward side of the levee looking downstream.

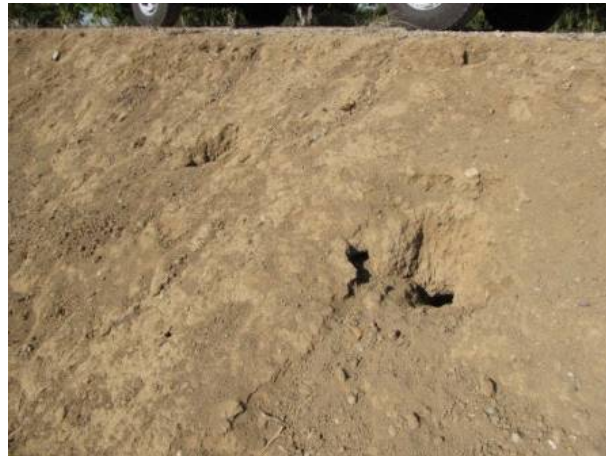
dpesaven_s_20100316_302.jpg

Levee Mile Report Line	117
Start Levee Mile	11.12
End Levee Mile	11.12
Location	Water Side
Category	Earthen Levee
Item	Animal Control

View of rodent holes in the waterward slope.

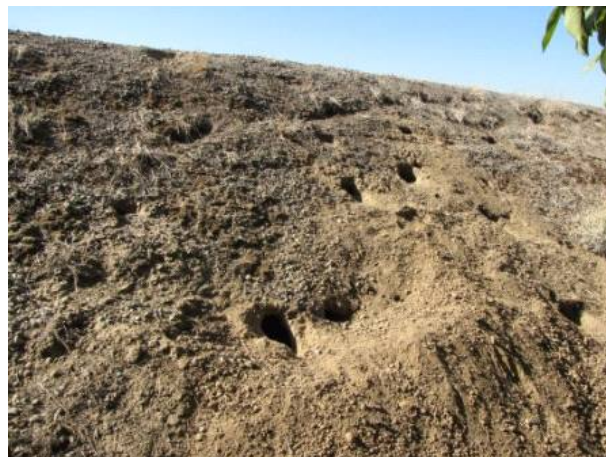
dpesaven_s_20100316_305.jpg

Levee Mile Report Line	126
Start Levee Mile	12.78
End Levee Mile	12.78
Location	Land Side
Category	Earthen Levee
Item	Animal Control

View of rodent holes in the landward slope of the levee.

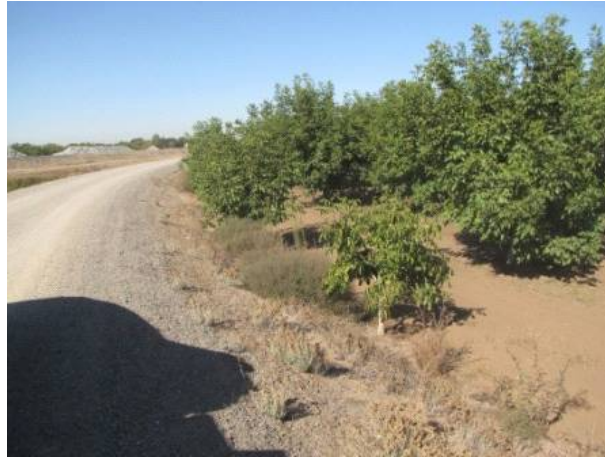
dpesaven_s_20100316_306.jpg

View of trees planted on the landward levee slope and toe looking downstream.

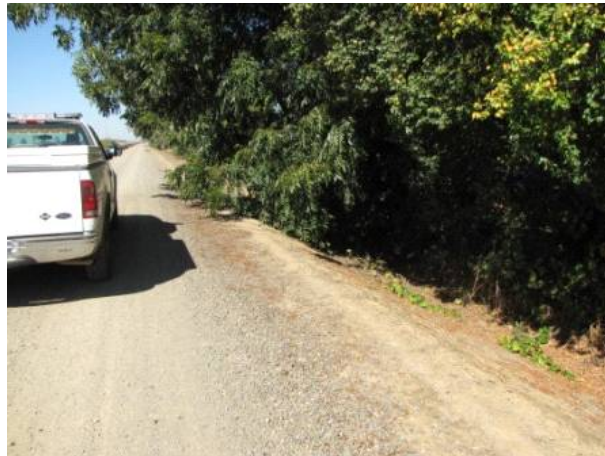
dpesaven_s_20100316_310.jpg

Levee Mile Report Line	142
Start Levee Mile	15.77
End Levee Mile	15.77
Location	Land Side
Category	Earthen Levee
Item	Trim / Thin Trees

View of tree branches blocking visibility and access along the landward slope of the levee looking downstream.

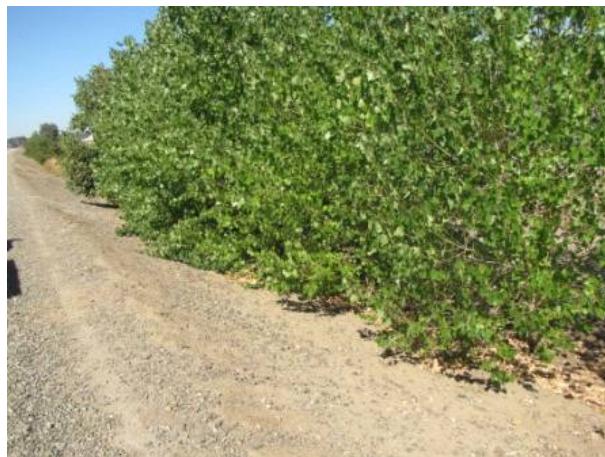
dpesaven_s_20100316_311.jpg

Levee Mile Report Line	143
Start Levee Mile	15.94
End Levee Mile	15.94
Location	Land Side
Category	Earthen Levee
Item	Encroachments

View of trees planted and maintained by the landowner along the landward toe looking downstream.

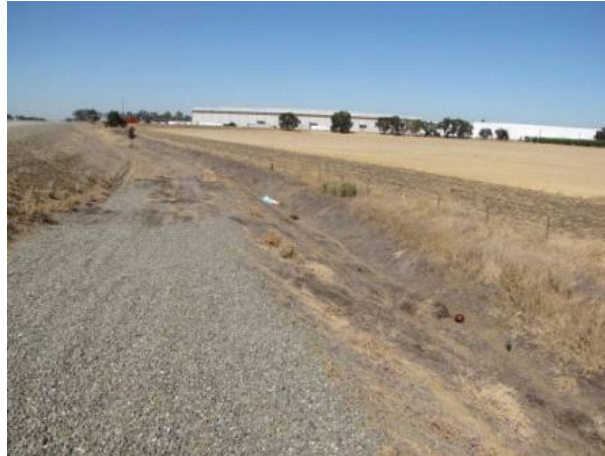
dpesaven_s_20100316_314.jpg

View of a ditch adjacent to the landward toe looking downstream.

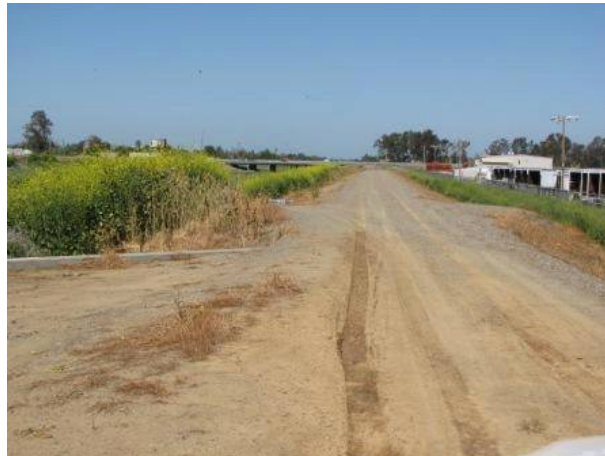
dpesaven_s_20100518_586.jpg

Levee Mile Report Line	147
Start Levee Mile	16.30
End Levee Mile	16.30
Location	Crown
Category	Earthen Levee
Item	Crown Surface / Depressions / Rutting

View of rutting occurring on the crown of the levee looking downstream.
